Fort Barrancas

Guide to Fort Barrancas

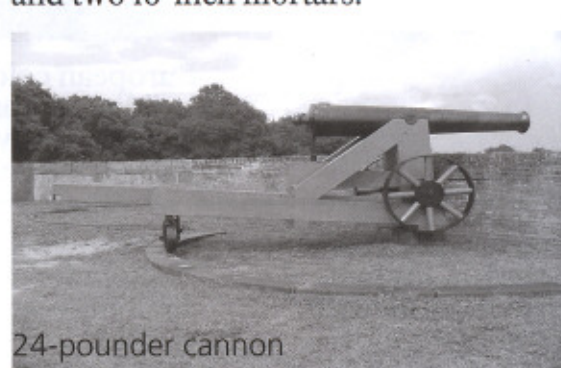
24-pounder cannon
